Inspection Report

149 Main street Hackettstown NJ 07840

Four Dogs Inspections

Date: 10/14/2022	Time: 09:30 AM	Report ID: Sample report
Property: 149 Main street Hackettstown NJ 07840	Customer: Sample Report	Real Estate Professional:

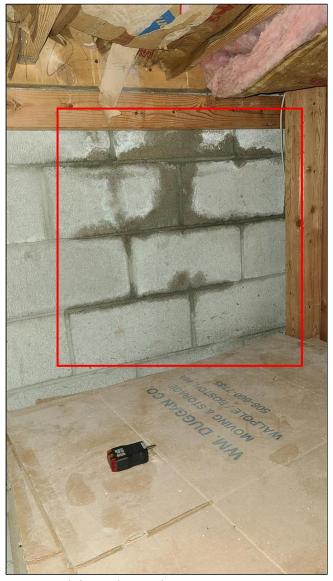
In the Crawlspace, this water intrusion is from the front porch and will need to be repaired before the sill and rim joist are damaged.

Recommend certified contractor address this issue.

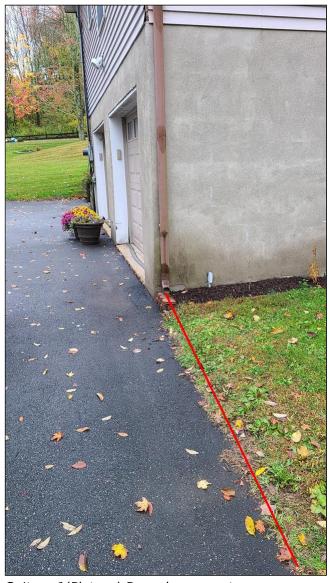
C. Item 1(Picture) Rear downspout

The downspout needs an extension or buried drain line to carry water away from the Foundation at the rear of home.

Recommend certified contractor address this issue.

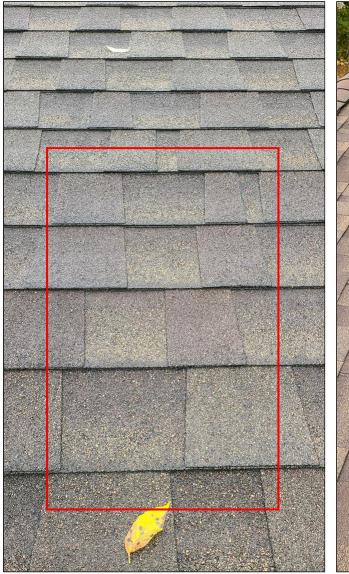
On the roof the shingles are damaged in several areas and will need to be repaired.

D. Item 1(Picture) The roof appeared to be in serviceable condition until I walked it. Looks to be about 12 to 15 years old, this type of shingle is warranted for 30 years.

Recommend certified contractor address this issue.

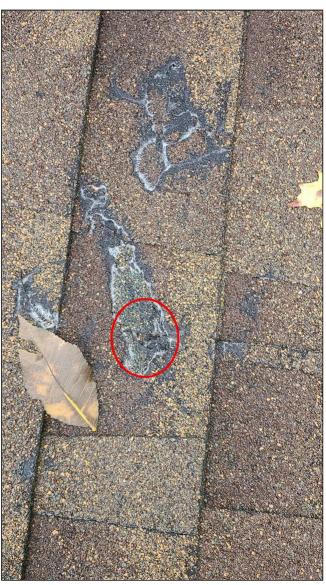
D. Item 4(Picture) Shingle damage down to the sheathing

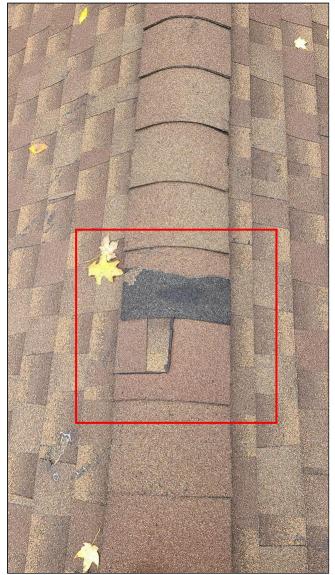
D. Item 5(Picture) Ridge damage

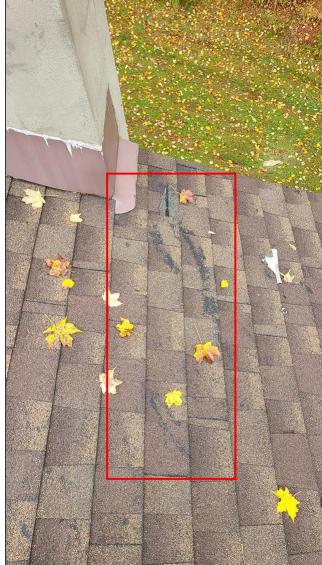
D. Item 6(Picture) Shingle damage

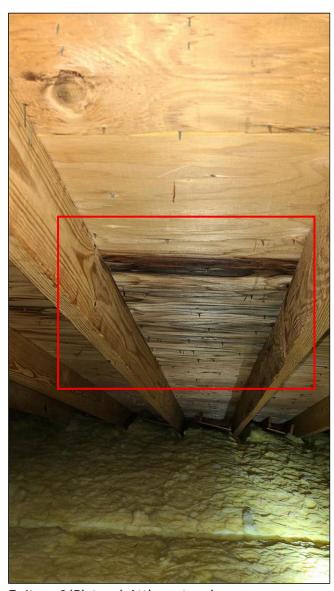
In the Attic space, there is discolored sheathing that is wet and will need to be repaired. The roof appears to have sustained damage that was never repaired.

Recommend certified contractor address this issue.

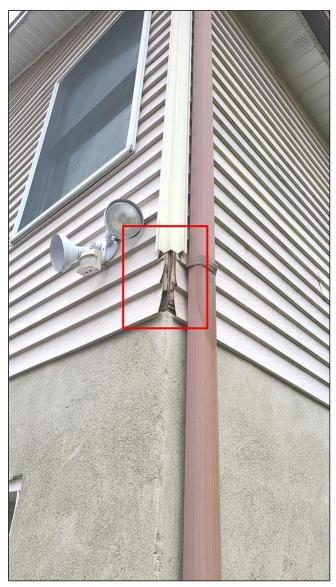
F. Item 1(Picture) Rear corner

On the Left rear corner of the home, this exposed wood is damaged and will need to be repaired.

Recommend certified contractor address this issue.

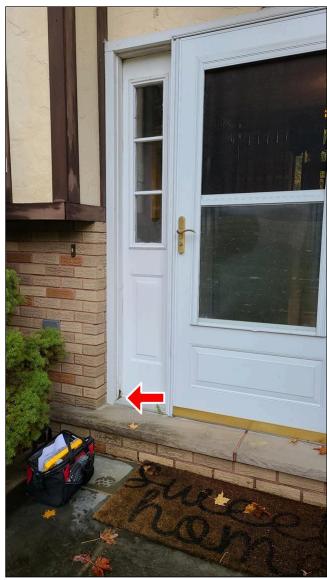
On the front door, this Left jamb is deteriorated.

H. Item 2(Picture) Deterioration

Recommend certified contractor address these issues.

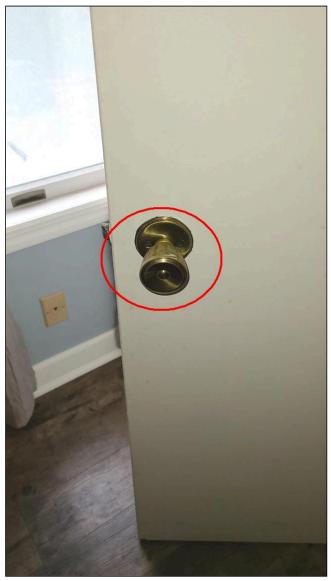
H. Item 3(Picture) The bathroom door handles do not lock.

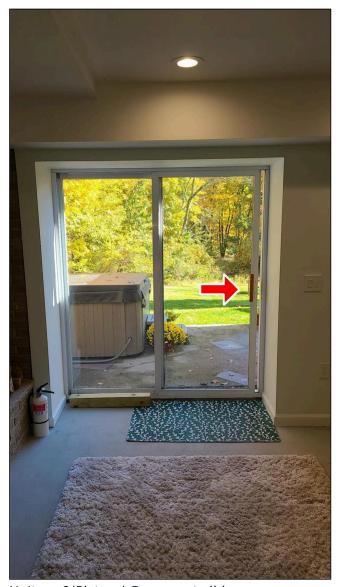
H. Item 9(Picture) Basement slider

In the Basement, this slider lock was not working when tested and will need to be repaired.

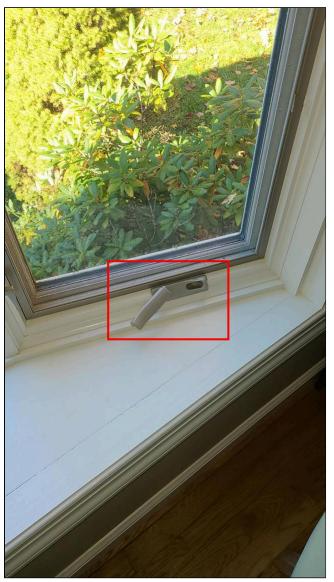
I. Item 2(Picture) Left side-

In the livingroom, these window cranks do not line up to close properly. This is an easy repair.

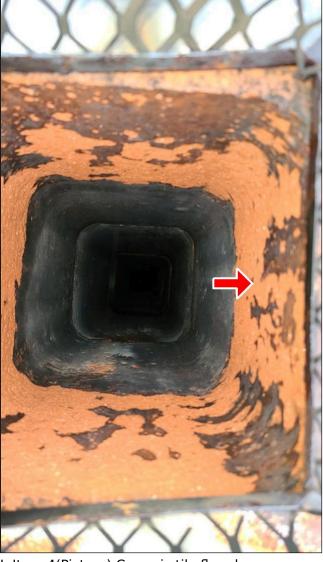
On the Furnace Chimney, there is not a cap installed with a cover, there is damage to the ceramic flue tiles and poor drainage from the gutters has severely damaged the cement stucco protective coating on the Chimney that will need to be repaired.

J. Item 4(Picture) Ceramic tile flue damage

Recommend certified Chimney contractor address these issues.

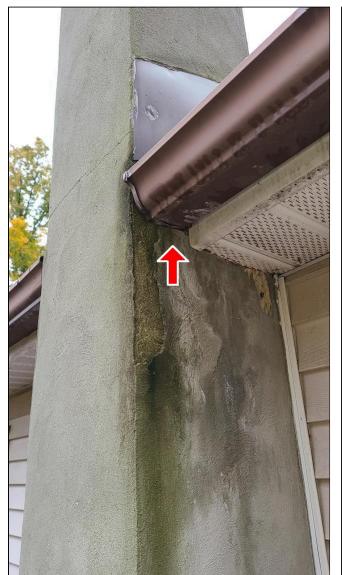
J. Item 5(Picture) Gutter leak damage

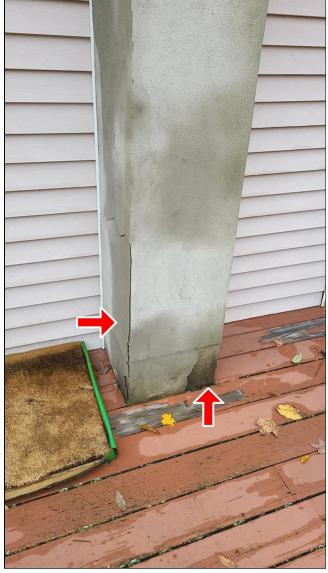
J. Item 7(Picture) Stucco damage

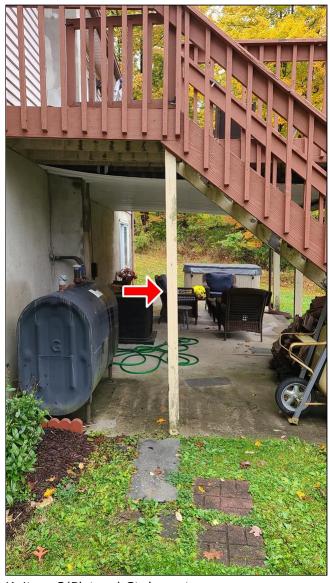
K. Item 3(Picture) Stair post

This 4x4 post is too small for the load and will need to be replaced.

Recommend certified contractor address these issues.

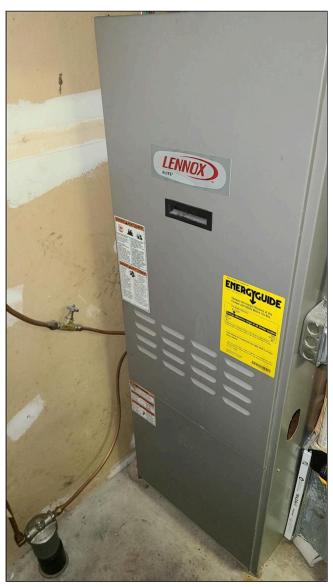
A. Item 1(Picture) Furnace

This LENNOX Oil fired Forced air Furnace was manufactured in April of 2008, and was working when tested. However there is evidence of condensate damage inside the unit.

Recommend certified HVAC contractor address these issues.

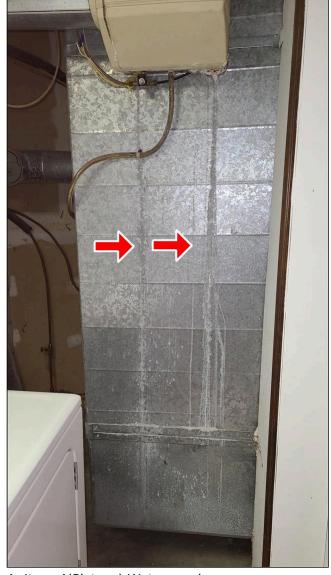
The humidifier is also leaking and damaging the ductwork, we were unable to test the unit.

A. Item 4(Picture) Water marks

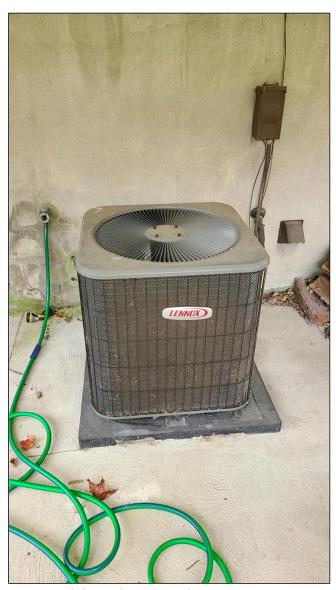
B. Item 1(Picture) A/C Condenser

(1) This LENNOX A/C Condenser was manufactured in January of 2008.

The A/C was not tested for proper operation due to the outside air temperature being 65 degrees or less. We did not test this unit.

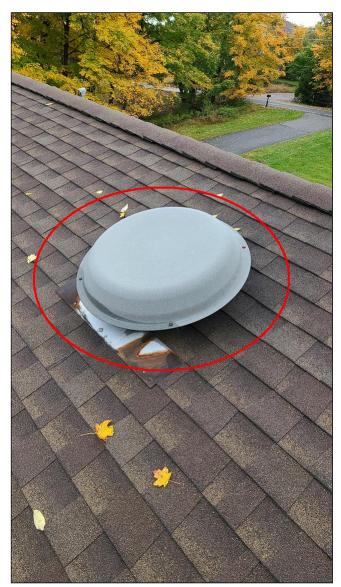
Both bathroom roof vents are clogged with bees nests.

Recommend certified contractor address these issues.

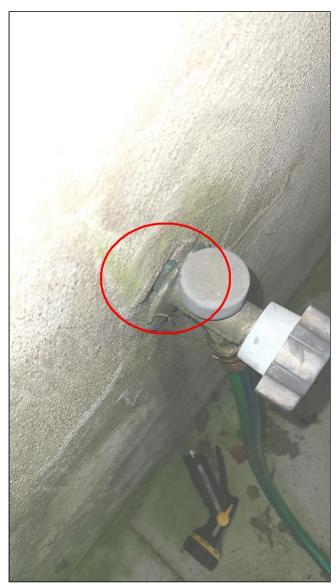
The spigot was also leaking inside the home and will need to be repaired.

Recommend certified Plumbing contractor address this issue.

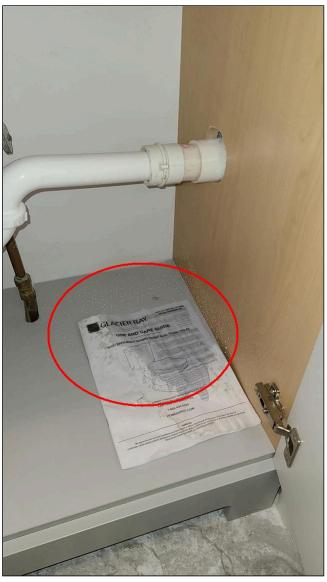
In the master bath, the vanity sink drain was leaking.

Recommend certified Plumbing contractor address these issues.

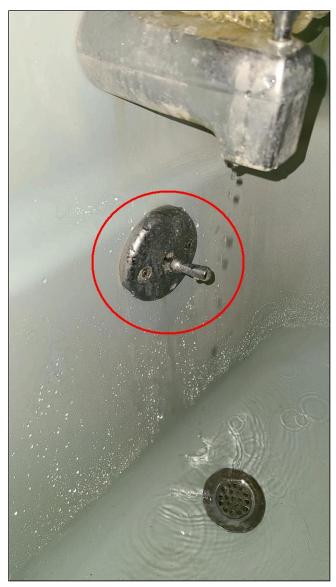
B. Item 2(Picture) Main bath

The main bath vanity sink drain stopper was also not working properly.

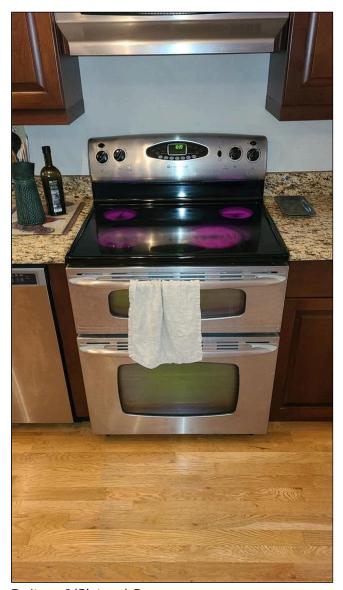
D. Item 1(Picture) Range

In the lower oven, the bake element was not working when tested.

Recommend certified contractor address this issue.
