Inspection Report

149 Main street Hackettstown NJ 07840

Four Dogs Inspections

Date: 10/14/2022	Time: 09:30 AM	Report ID: Sample report
Property: 149 Main street Hackettstown NJ 07840	Customer: Sample Report	Real Estate Professional:

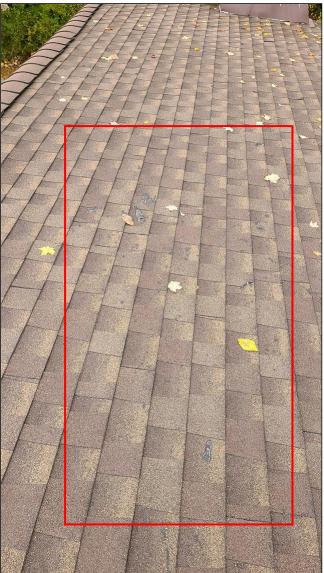
D. Item 2(Picture)

On the roof the shingles are damaged in several areas and will need to be repaired.

Recommend certified contractor address this issue.

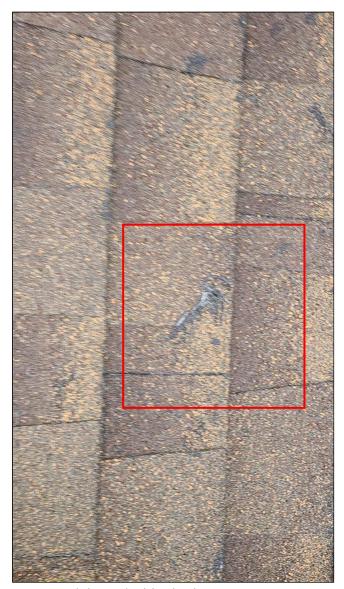
D. Item 4(Picture) Shingle damage down to the sheathing

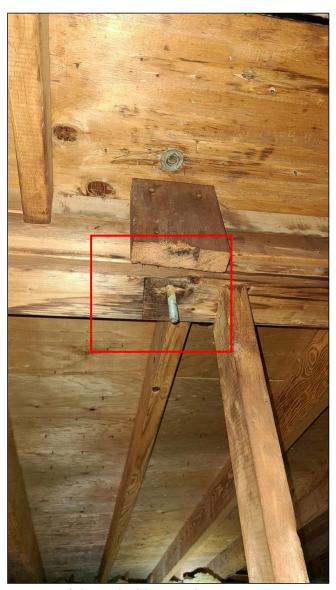
In the Attic space, there is discolored sheathing that is wet and will need to be repaired. The roof appears to have sustained damage that was never repaired.

E. Item 2(Picture) This was dry

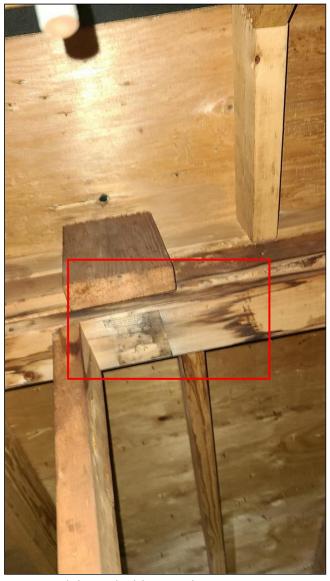
E. Item 3(Picture) This was dry

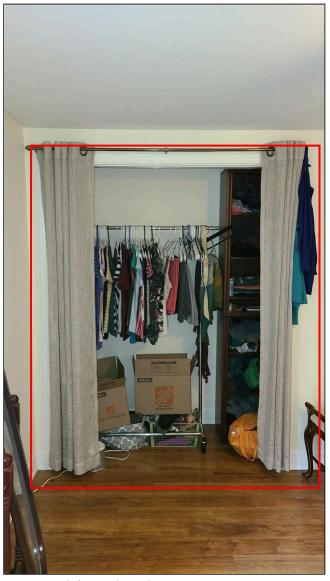
H. Item 4(Picture) Bedroom

All 3 of the bedroom closet doors are missing and will need to be replaced.

Recommend certified contractor address these issues.

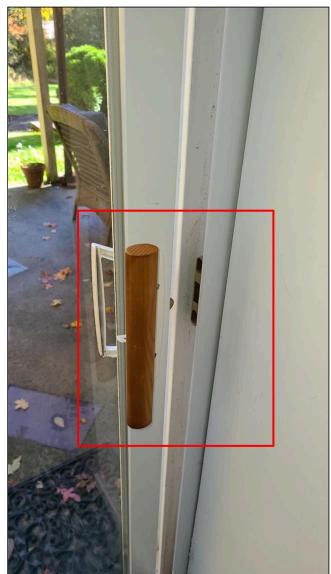
In the Basement, this slider lock was not working when tested and will need to be repaired.

H. Item 8(Picture) Slider lock

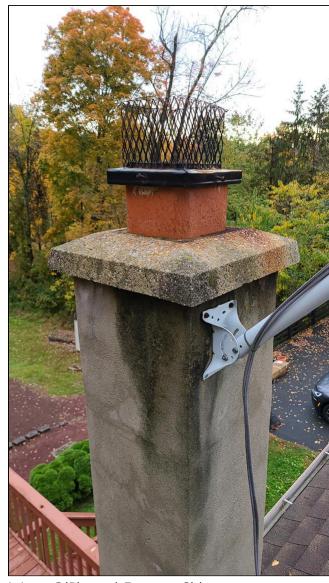
J. Item 3(Picture) Furnace Chimney

On the Furnace Chimney, there is not a cap installed with a cover, there is damage to the ceramic flue tiles and poor drainage from the gutters has severely damaged the cement stucco protective coating on the Chimney that will need to be repaired.

Recommend certified Chimney contractor address these issues.

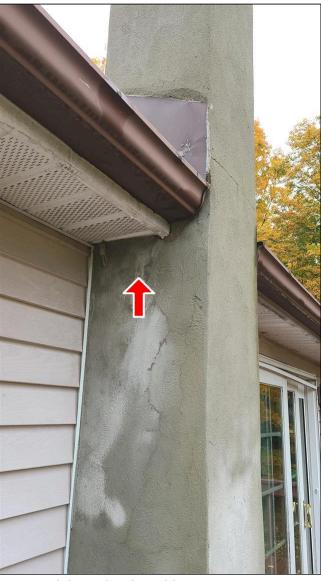
J. Item 5(Picture) Gutter leak damage

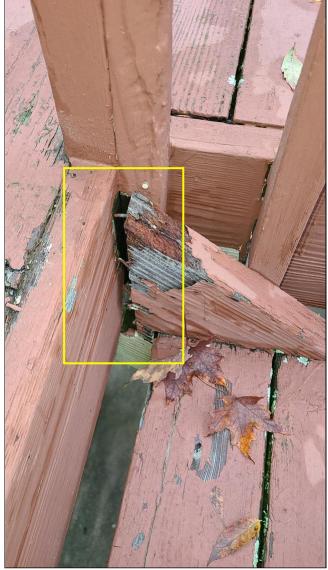
The steps are not properly secured to the decks rim joist and will need to be repaired.

K. Item 2(Picture) Stairs

Recommend certified contractor address these issues.

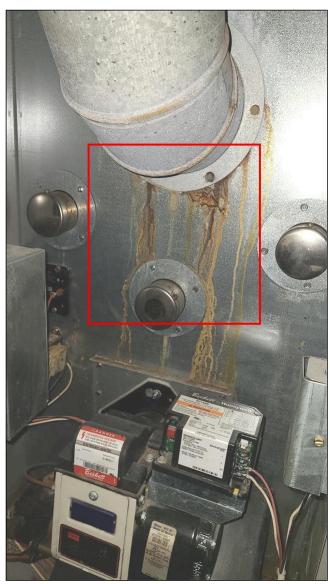
This LENNOX Oil fired Forced air Furnace was manufactured in April of 2008, and was working when tested. However there is evidence of condensate damage inside the unit.

A. Item 2(Picture) Condensate

Recommend certified HVAC contractor address these issues.

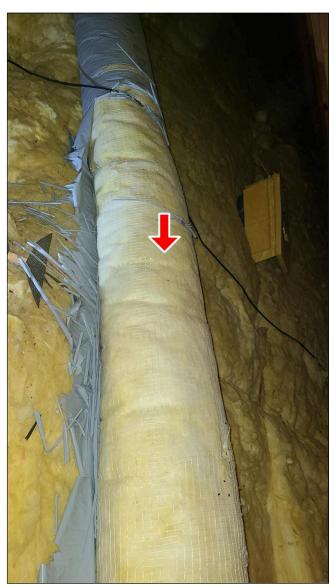
C. Item 6(Picture) Attic

In the Attic, the ductwork is damaged and will need to be repaired.

Recommend certified contractor address these issues.

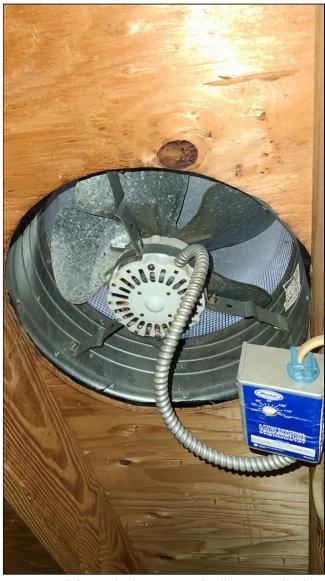
C. Item 8(Picture) Thermostatically controlled Attic roof vent most likely works as the blades turned freely.

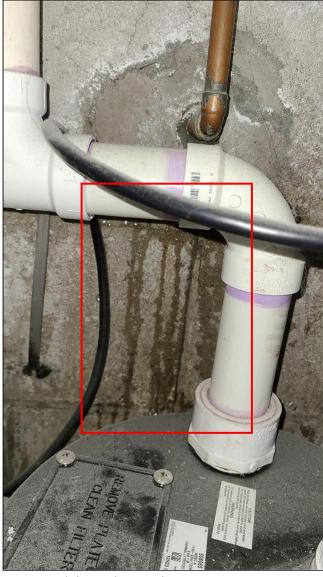
A. Item 3(Picture) Laundry room

The spigot was also leaking inside the home and will need to be repaired.

Recommend certified Plumbing contractor address this issue.

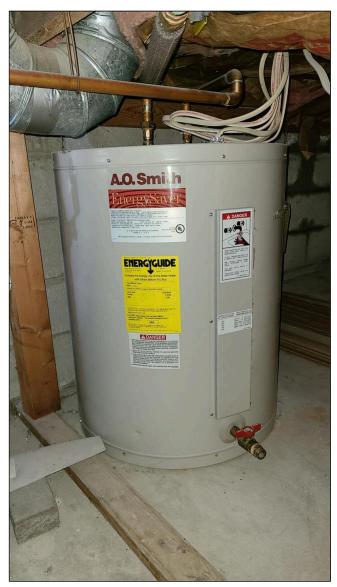
C. Item 1(Picture) Hot water heater

This 50 Gallon Electric A. O. SMITH Electric hot water heater was manufactured in July of 2003, and was working when tested.

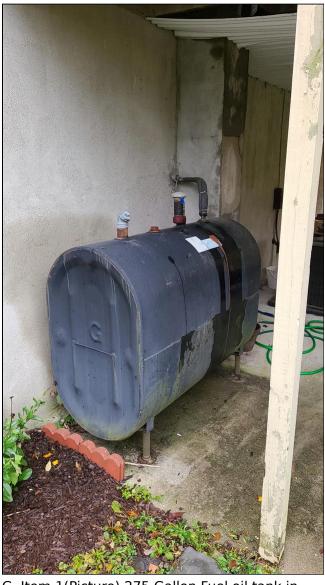
G. Item 1(Picture) 275 Gallon Fuel oil tank in the rear of the home.

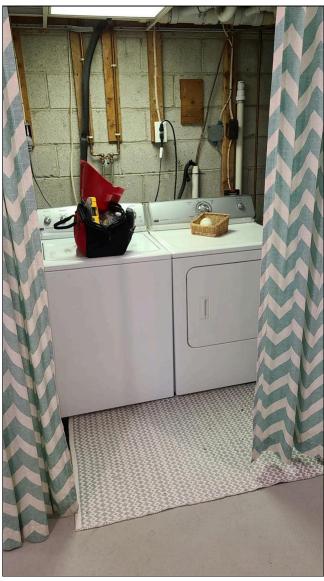
M. Item 1(Picture) Washer and dryer were working when tested.

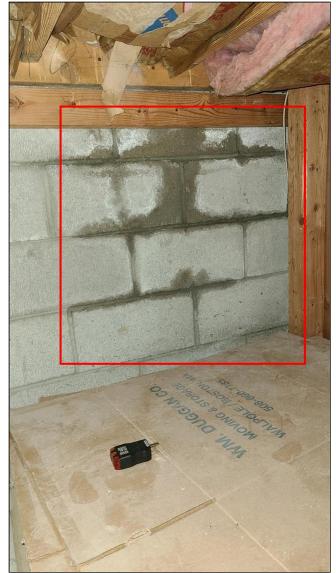
In the Crawlspace, this water intrusion is from the front porch and will need to be repaired before the sill and rim joist are damaged.

A. Item 1(Picture) Crawlspace

Recommend certified contractor address this issue.

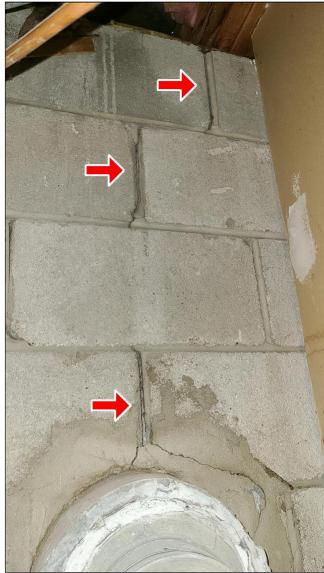
A. Item 2(Picture) Rear settling crack

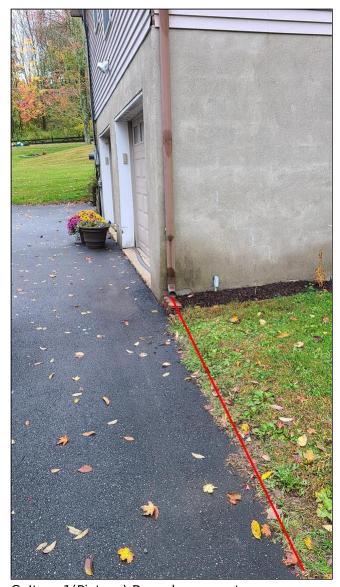
The downspout needs an extension or buried drain line to carry water away from the Foundation at the rear of home.

C. Item 1(Picture) Rear downspout

Recommend certified contractor address this issue.

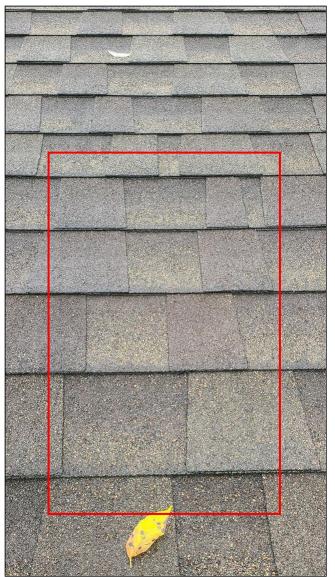
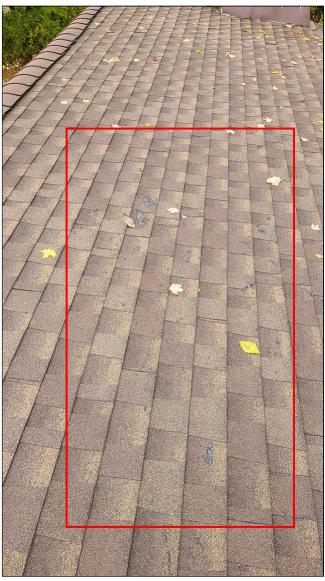
D. Item 2(Picture)

On the roof the shingles are damaged in several areas and will need to be repaired.

Recommend certified contractor address this issue.

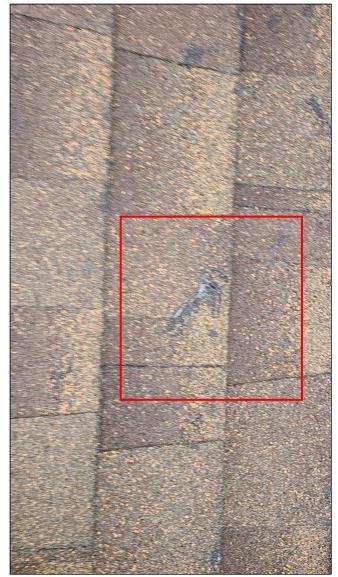
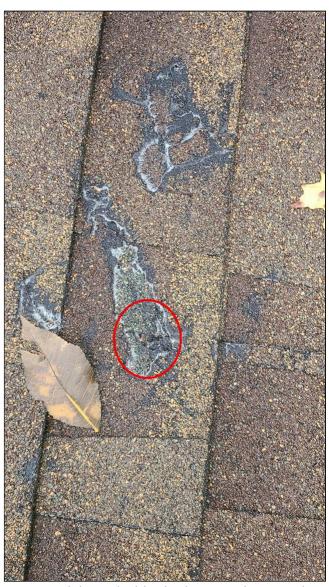
D. Item 4(Picture) Shingle damage down to the sheathing

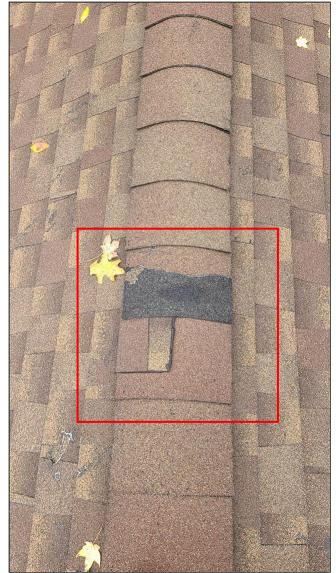
D. Item 5(Picture) Ridge damage

D. Item 6(Picture) Shingle damage

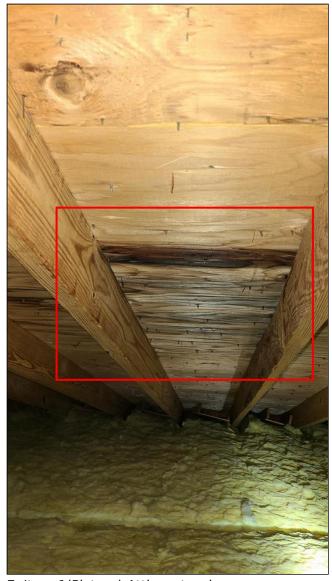
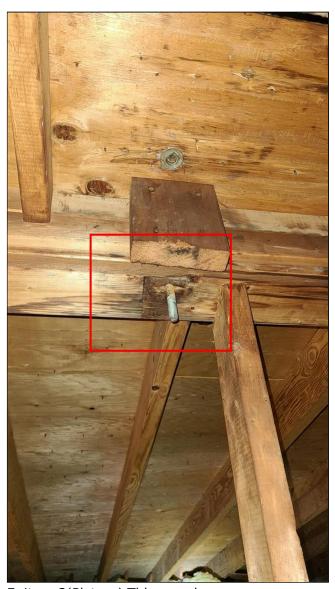
In the Attic space, there is discolored sheathing that is wet and will need to be repaired. The roof appears to have sustained damage that was never repaired.

E. Item 2(Picture) This was dry

Recommend certified contractor address this issue.

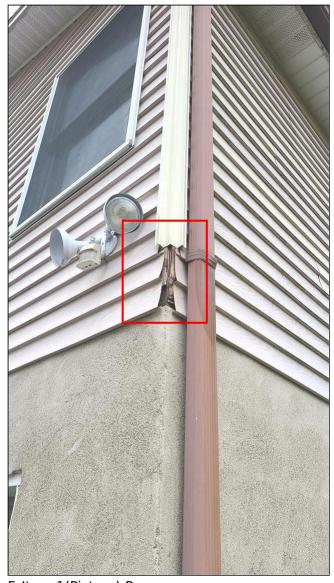
On the Left rear corner of the home, this exposed wood is damaged and will need to be repaired.

F. Item 1(Picture) Rear corner

Recommend certified contractor address this issue.

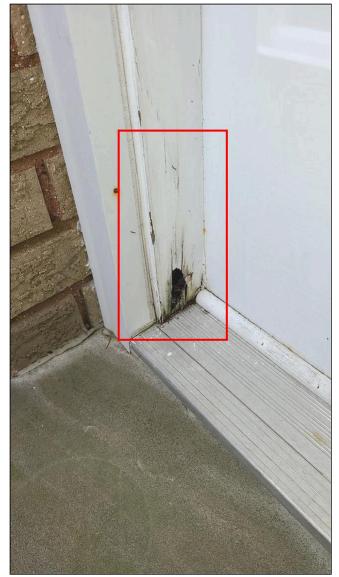
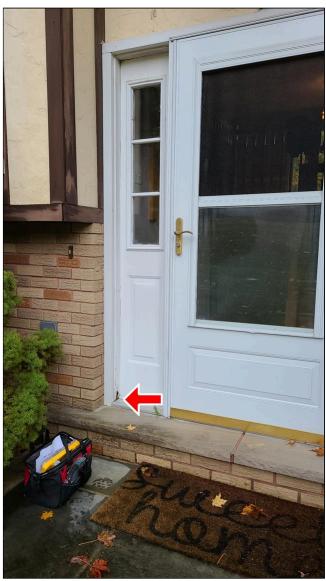
On the front door, this Left jamb is deteriorated.

H. Item 2(Picture) Deterioration

Recommend certified contractor address these issues.

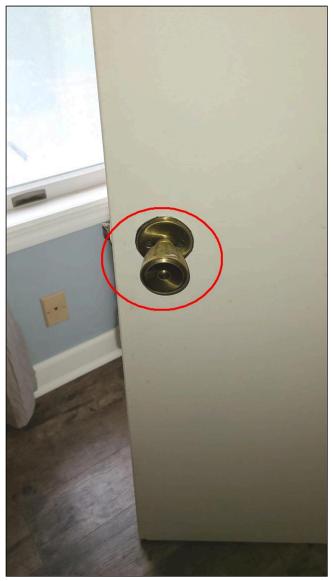
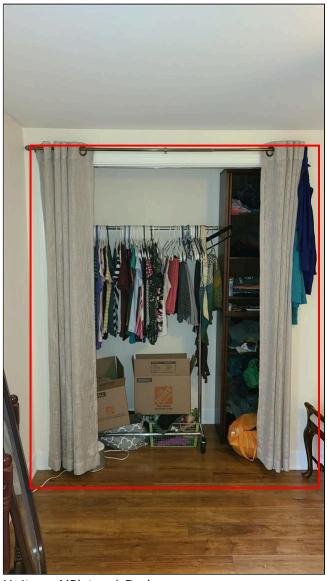
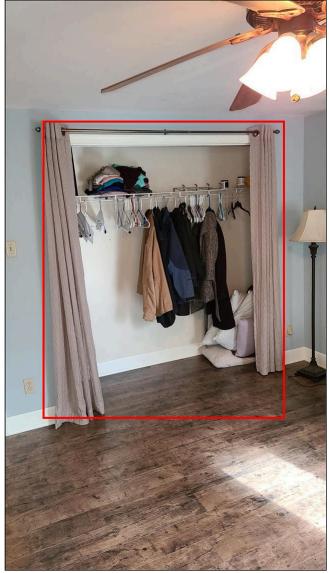
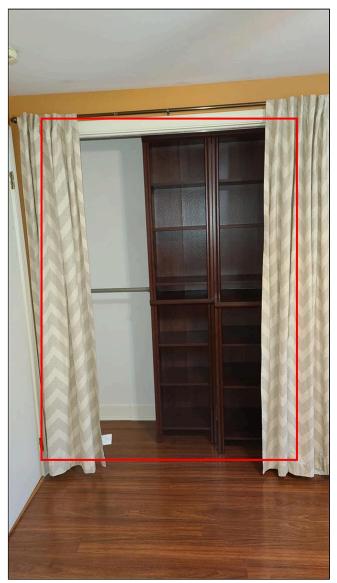
All 3 of the bedroom closet doors are missing and will need to be replaced.

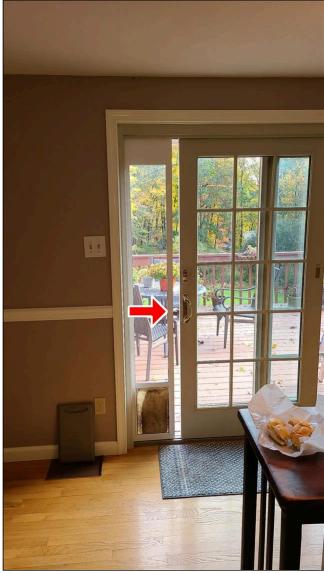
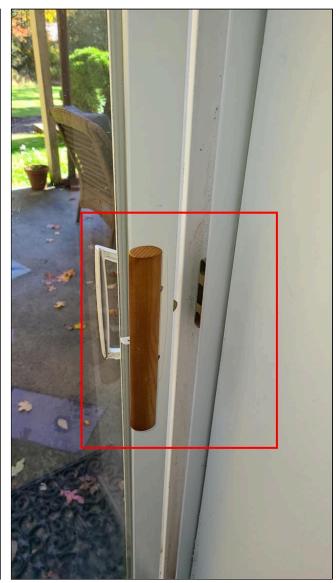
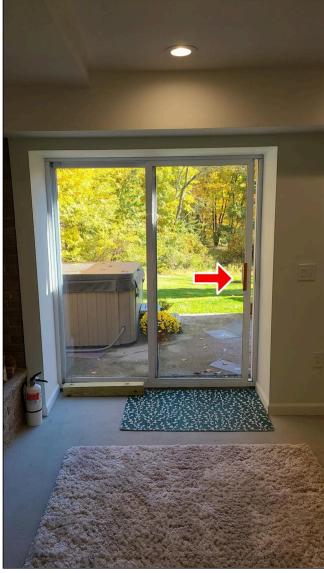
In the Basement, this slider lock was not working when tested and will need to be repaired.

H. Item 8(Picture) Slider lock

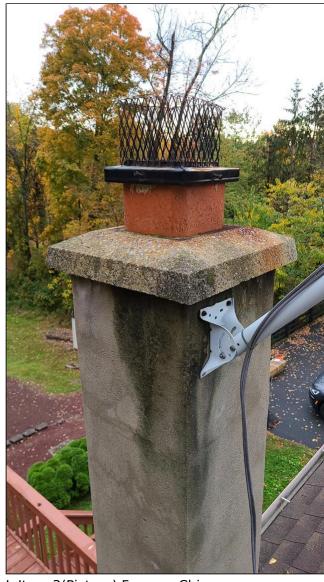
On the Furnace Chimney, there is not a cap installed with a cover, there is damage to the ceramic flue tiles and poor drainage from the gutters has severely damaged the cement stucco protective coating on the Chimney that will need to be repaired.

J. Item 3(Picture) Furnace Chimney

Recommend certified Chimney contractor address these issues.

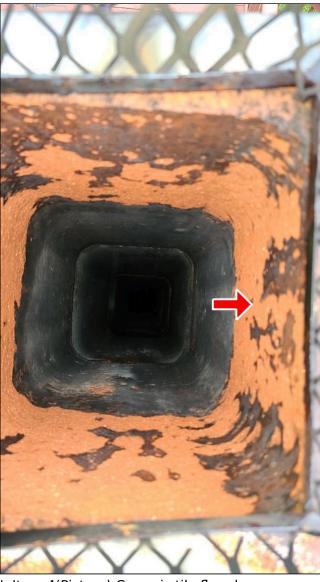
J. Item 4(Picture) Ceramic tile flue damage

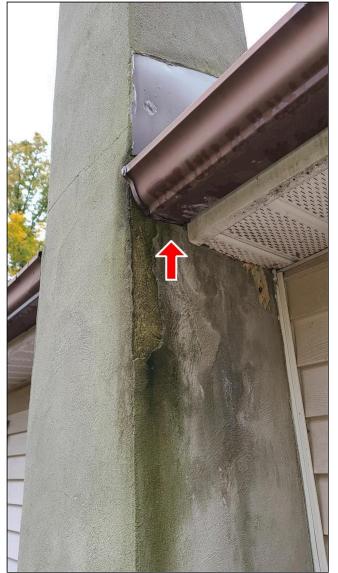
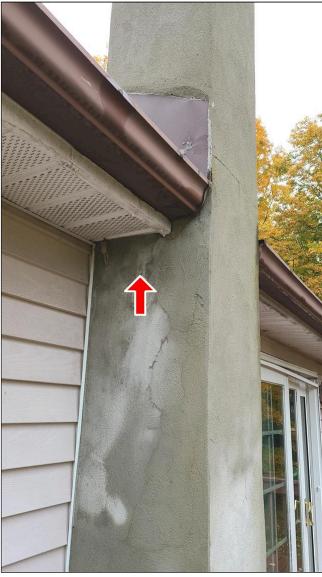
J. Item 5(Picture) Gutter leak damage

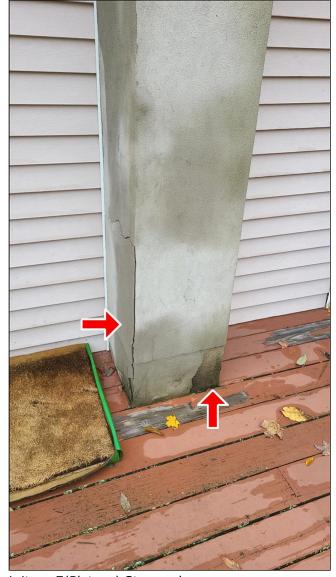
J. Item 7(Picture) Stucco damage

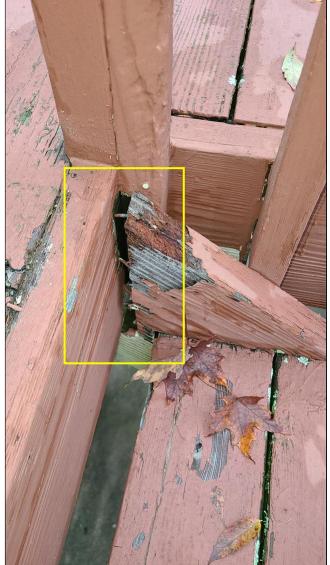
The steps are not properly secured to the decks rim joist and will need to be repaired.

K. Item 2(Picture) Stairs

Recommend certified contractor address these issues.

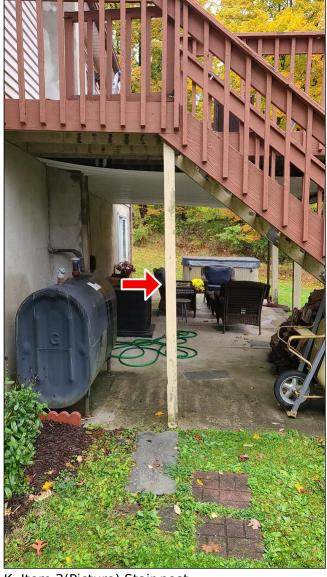
This 4x4 post is too small for the load and will need to be replaced.

K. Item 3(Picture) Stair post

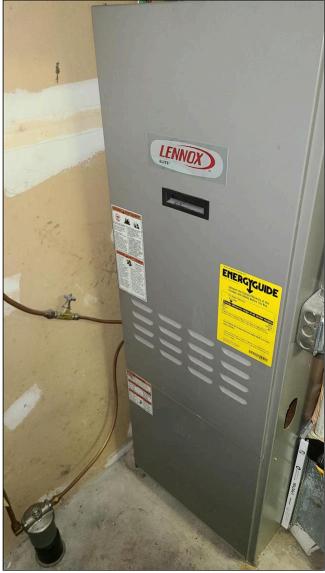
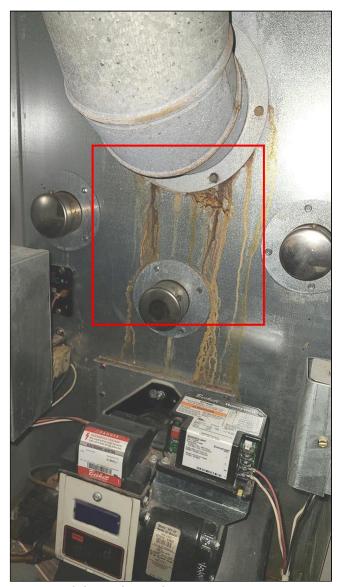
This LENNOX Oil fired Forced air Furnace was manufactured in April of 2008, and was working when tested. However there is evidence of condensate damage inside the unit.

A. Item 2(Picture) Condensate

Recommend certified HVAC contractor address these issues.

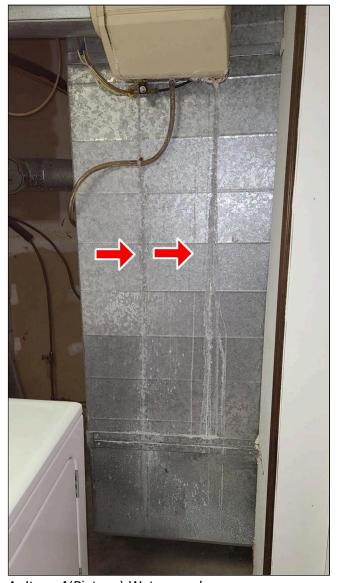
The humidifier is also leaking and damaging the ductwork, we were unable to test the unit.

A. Item 4(Picture) Water marks

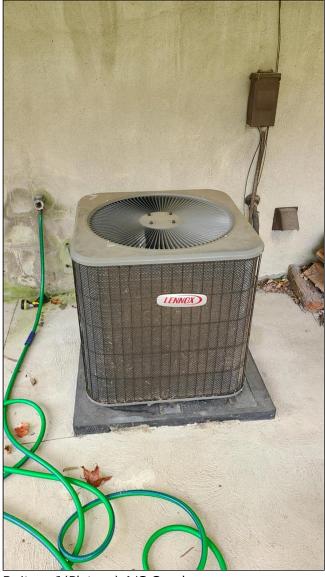
B. Item 1(Picture) A/C Condenser

(2) The condenser is missing foam sleeve in area(s). Missing foam on the suction line can cause energy loss and condensation.

A licensed HVAC contractor should service or repair unit.

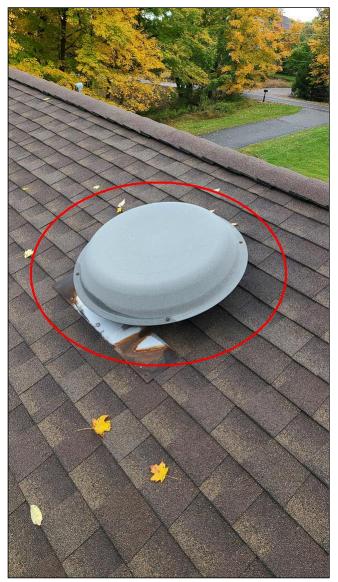
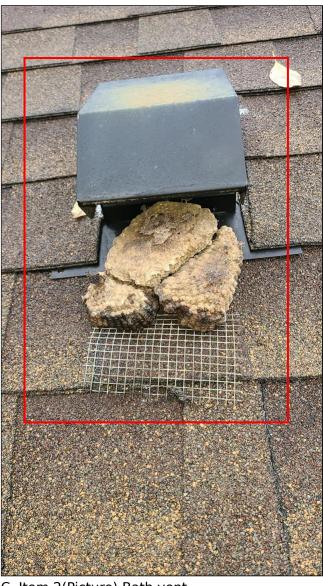
C. Item 2(Picture) Bath vent

Recommend certified contractor address these issues.

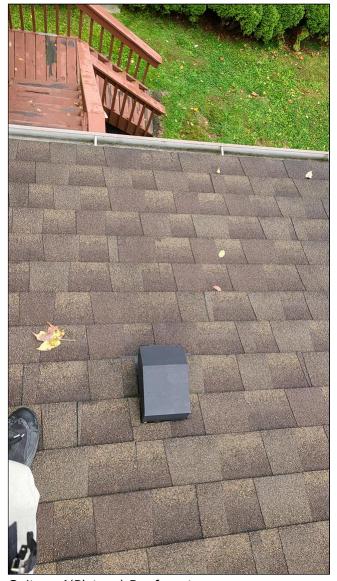
C. Item 4(Picture) Roof vent

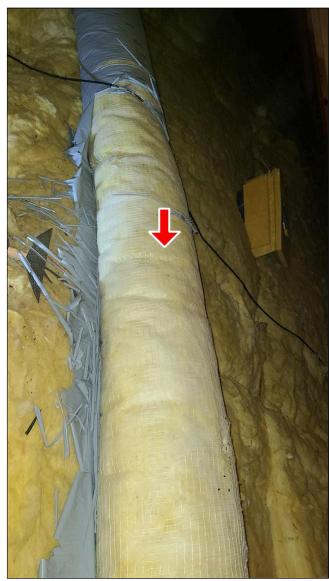
C. Item 6(Picture) Attic

In the Attic, the ductwork is damaged and will need to be repaired.

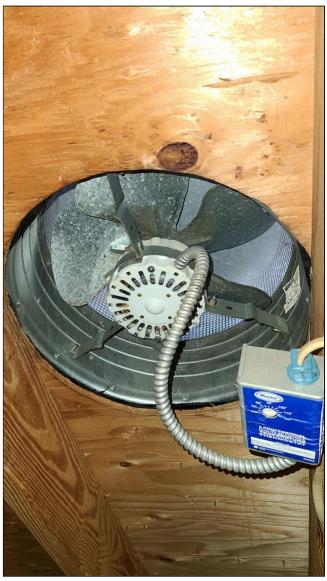
C. Item 8(Picture) Thermostatically controlled Attic roof vent most likely works as the blades turned freely.

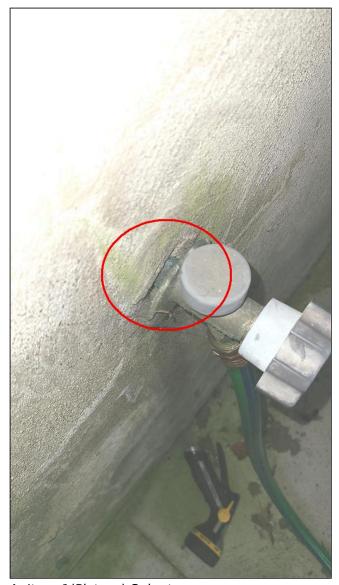
A. Item 1(Picture) Spigot

The spigot was also leaking inside the home and will need to be repaired.

Recommend certified Plumbing contractor address this issue.

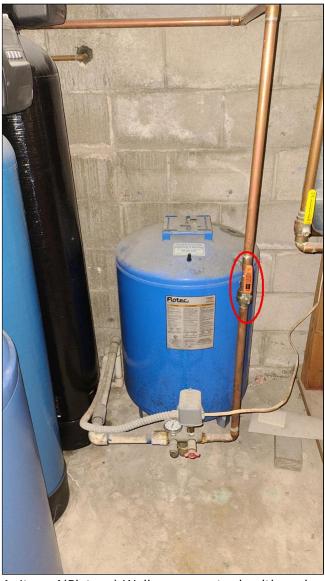
A. Item 4(Picture) Well pressure tank with main water shut-off circled.

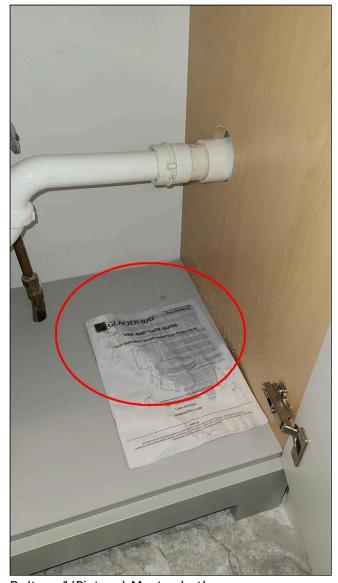
B. Item 1(Picture) Master bath

In the master bath, the vanity sink drain was leaking.

Recommend certified Plumbing contractor address these issues.
